# IT'S STILL RIGHT! CARDIOMEMS DEVICE MIGRATION FROM LEFT TO RIGHT PULMONARY ARTERY

Waseem Farooq MD, Haris Athar MD  
St. Francis Hospital Hartford Connecticut  
University of Connecticut School of Medicine Farmington Connecticut

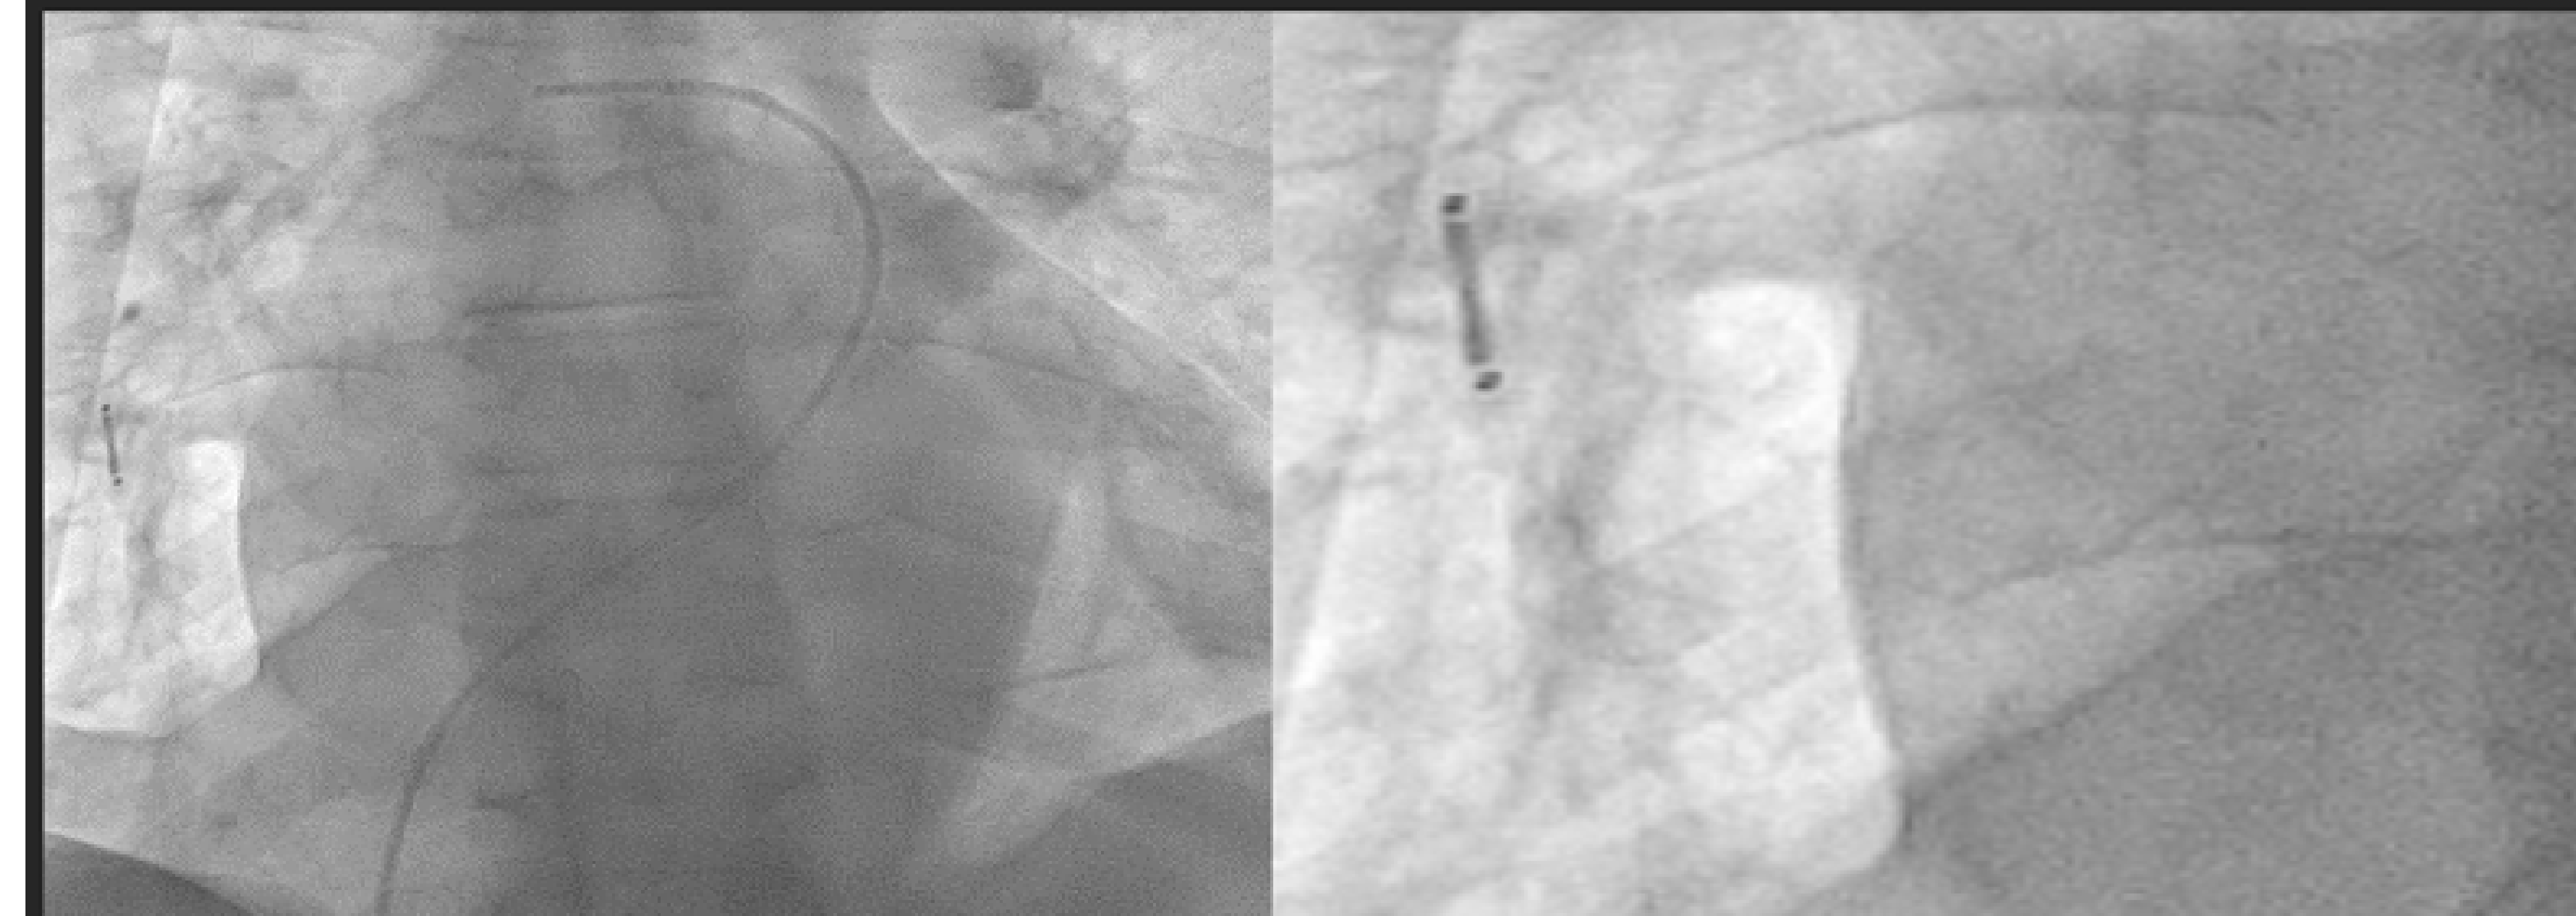
Right heart catheterization showing device migration to the right pulmonary artery. Zoomed in view.

Follow up imaging showed device migration into the right pulmonary arterial system. Repeat right heart catheterization was obtained which showed accurate and consistent pulmonary artery pressure readings from the device. Since PA pressure measurements were unaffected, no changes were made, and outpatient follow up was continued.
