# Rib Healing and Heterotopic Ossification After Surgical Stabilization of Rib Fractures

Alexander Hoey <sup>1</sup>, Daniel Akyeampong <sup>1</sup>, Arjun Patel <sup>1</sup>, Ronald Gross <sup>2</sup> and Evert A. Eriksson <sup>1</sup>

<sup>1</sup>Medical University of South Carolina, Charleston, SC; <sup>2</sup>Trinity Health of New England, Hartford, CT

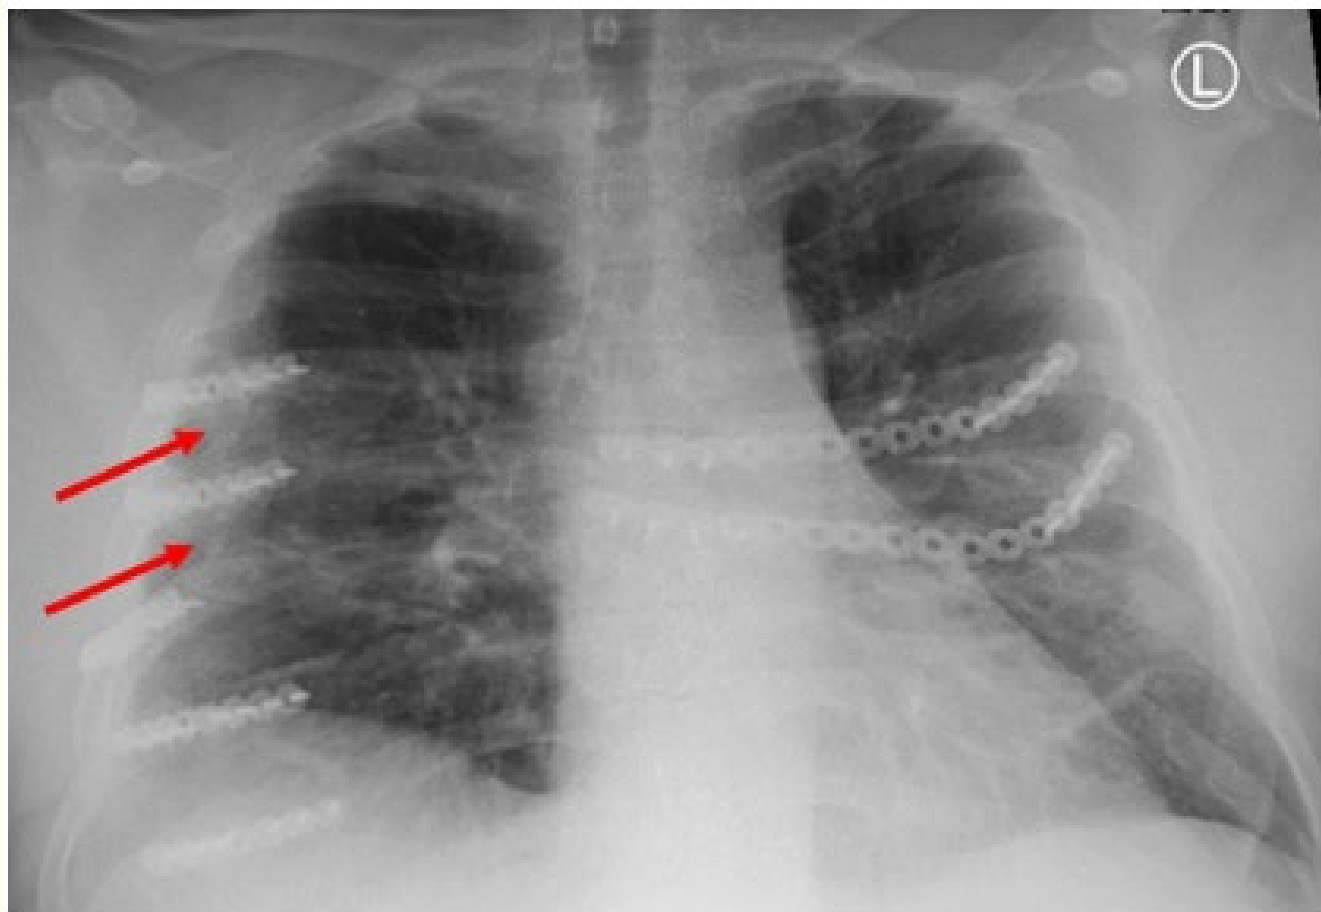
Figure 1. Chest X-ray showing HO at the tips of the red arrows.

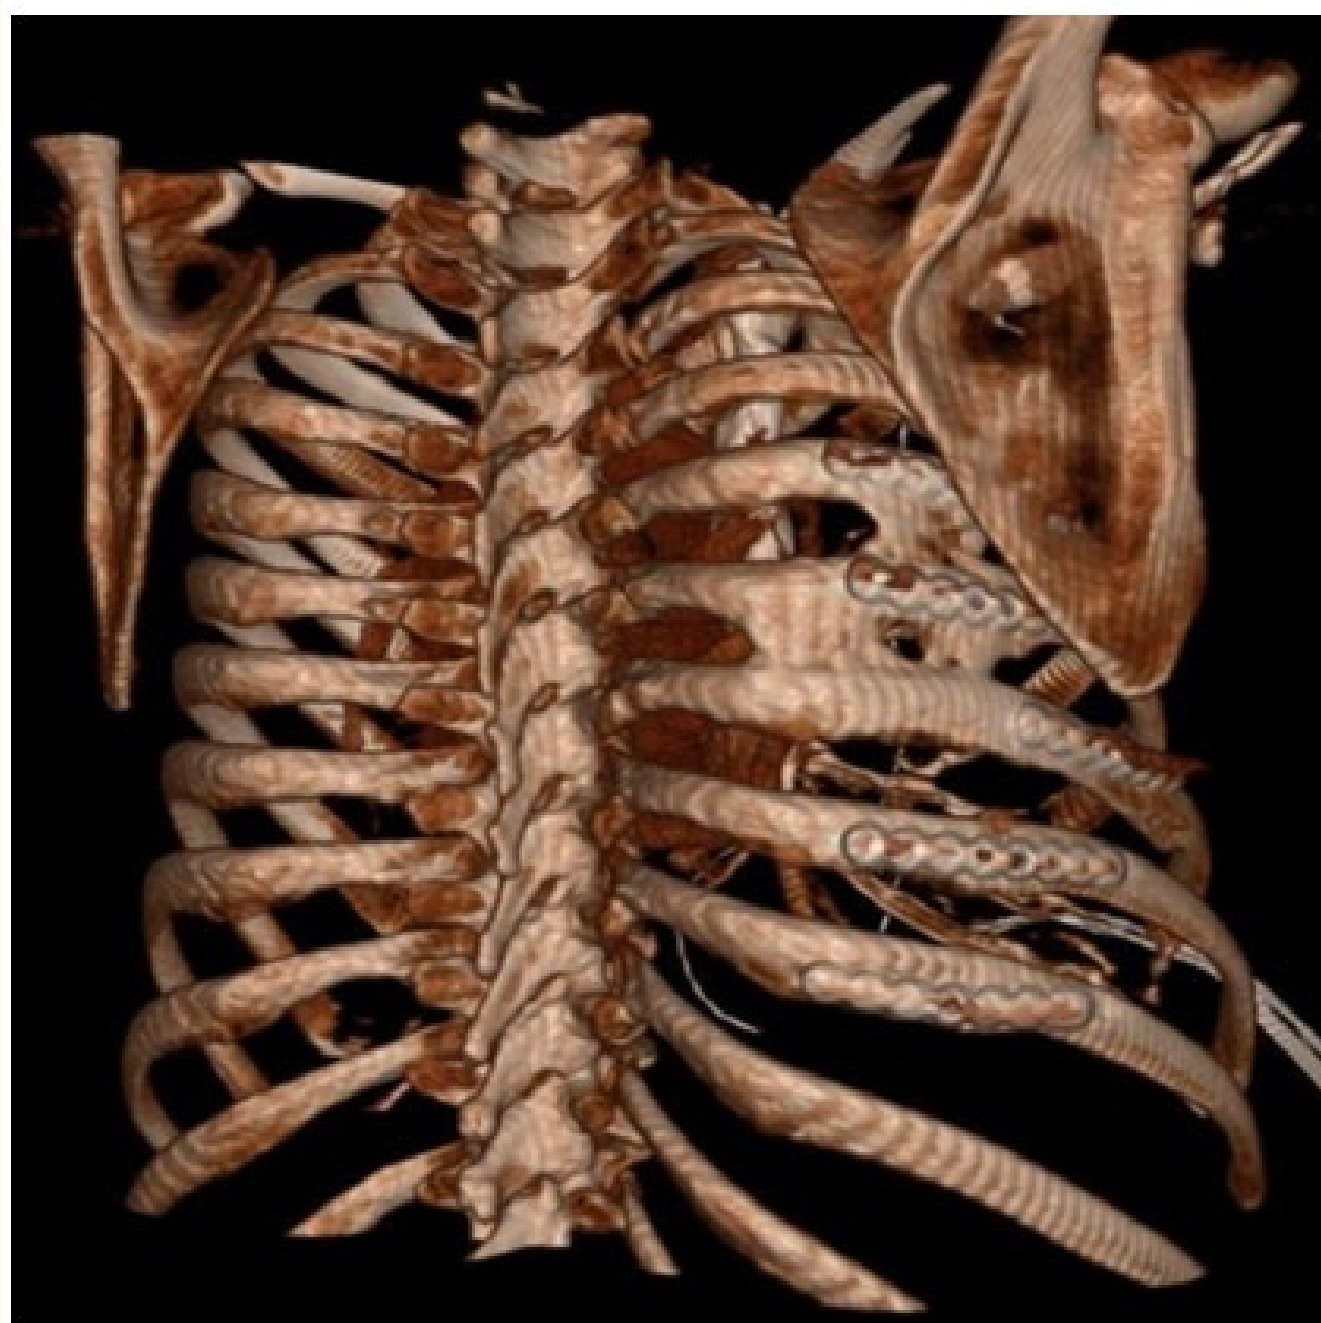
Figure 2. Three-dimensional reconstruction of CT scan with HO between ribs.
